Non-destructive Testing of Fiber Composite Components - Case Study: Rotor Blades of Wind Turbines

Joint research project **BladeTester** -
Automated approach for serial integrity tests of rotor blades
2011-2015

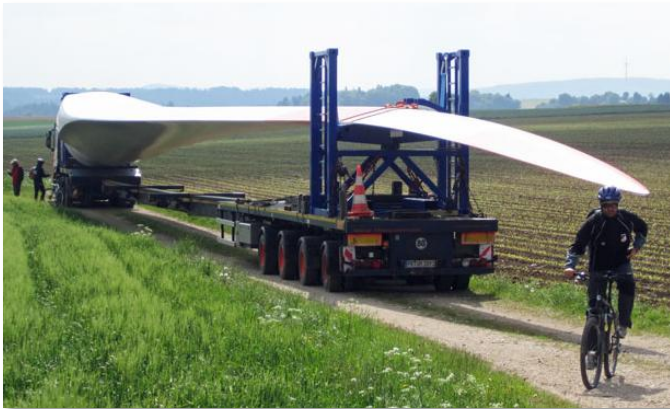
Deformation under dead weight

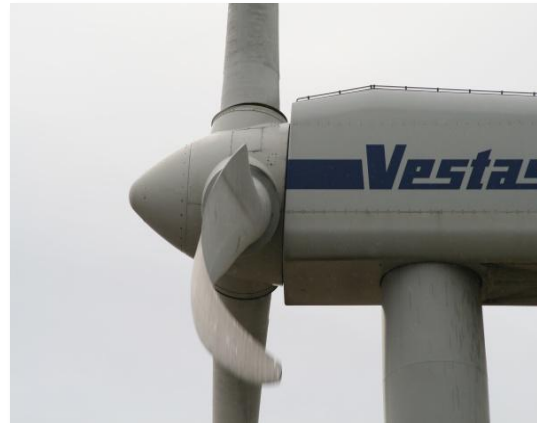
Deformation in operation

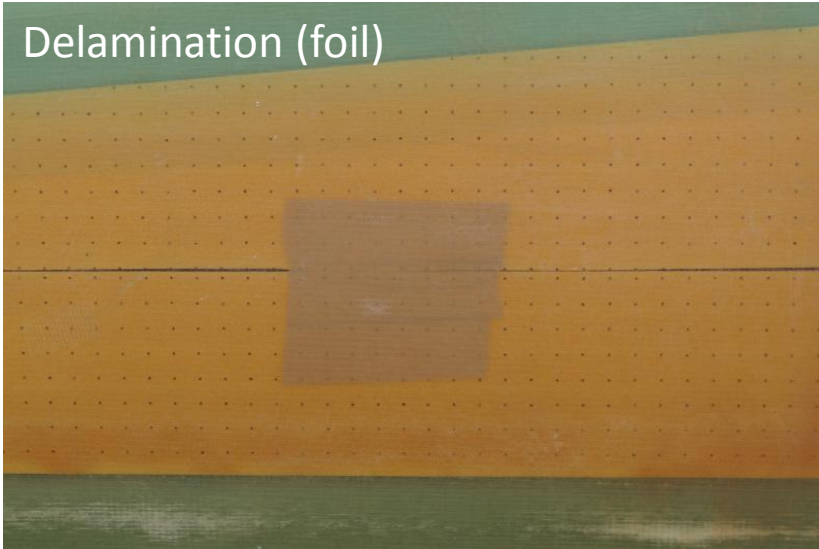
Delamination (foil)

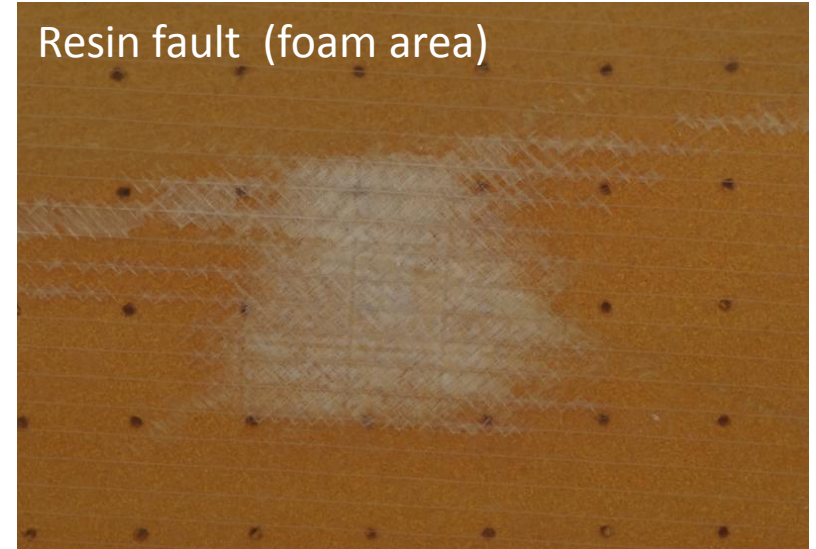
Resin fault (foam area)

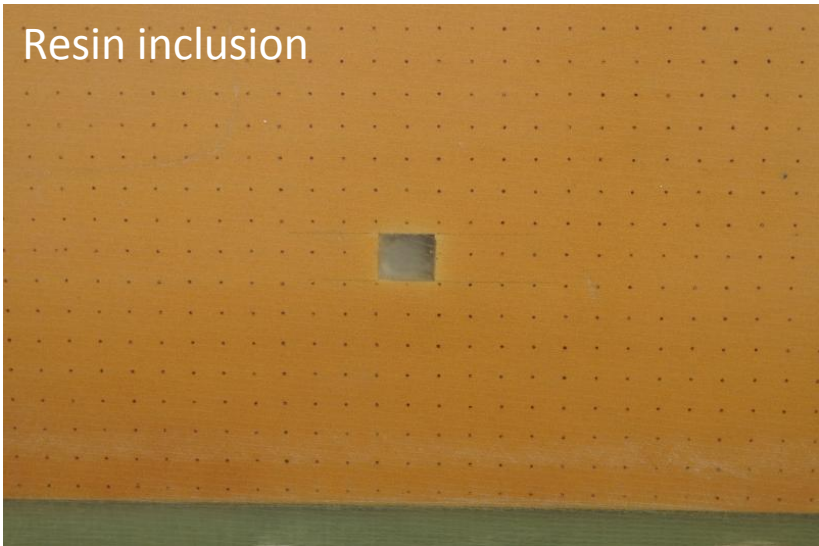
Resin inclusion

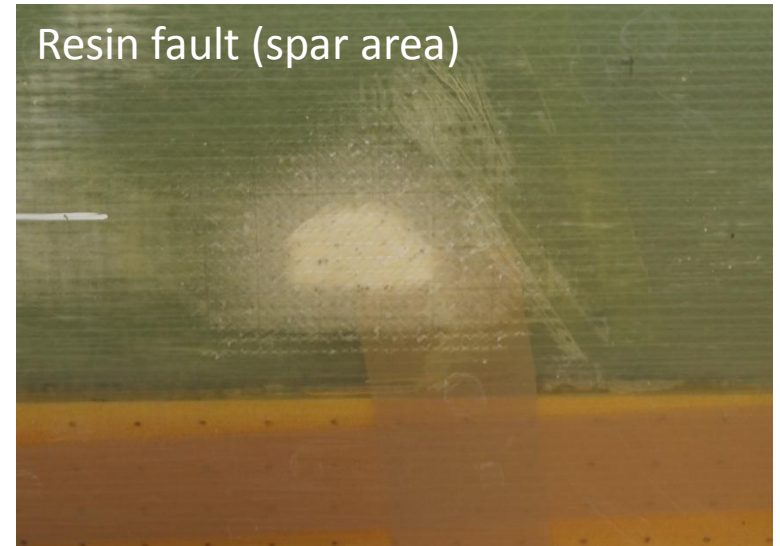
Resin fault (spar area)

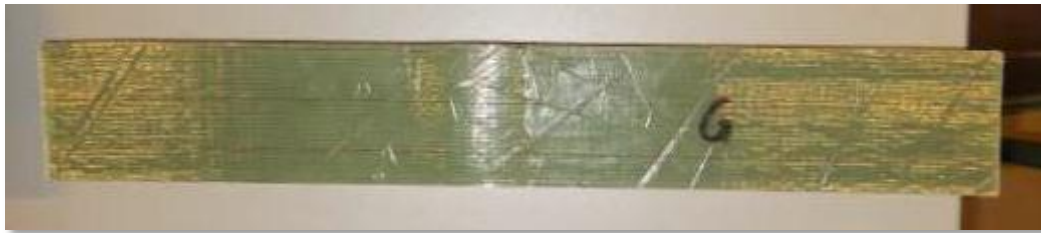
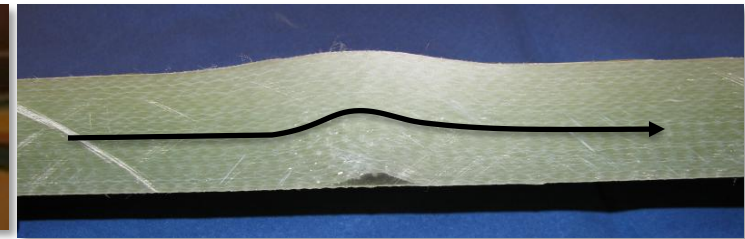
Hidden ondulation in composite, stress field disturbance, potential failure source

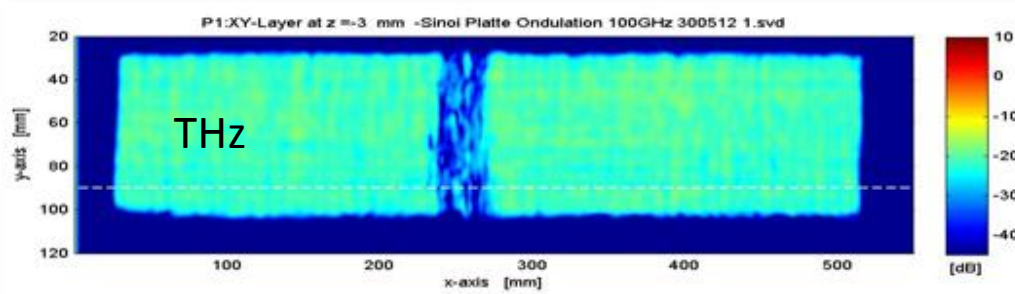
- μ -waves C-Scan (FIT-M)
10 GHz, wave length 3 cm

- THz-Scan (Becker Photonik)
100 GHz, wave length 3 mm

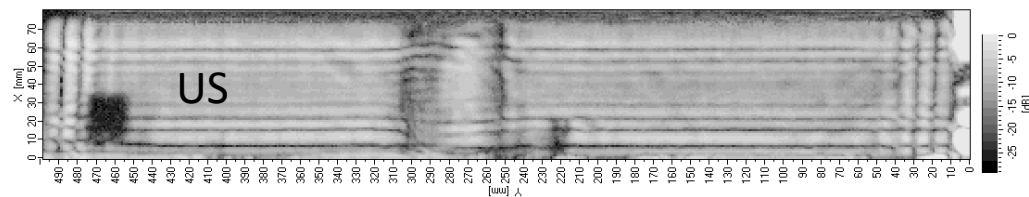
- US-Scan (MUSE Z-400
Dr. Hillger)
0.5-1.0 MHz

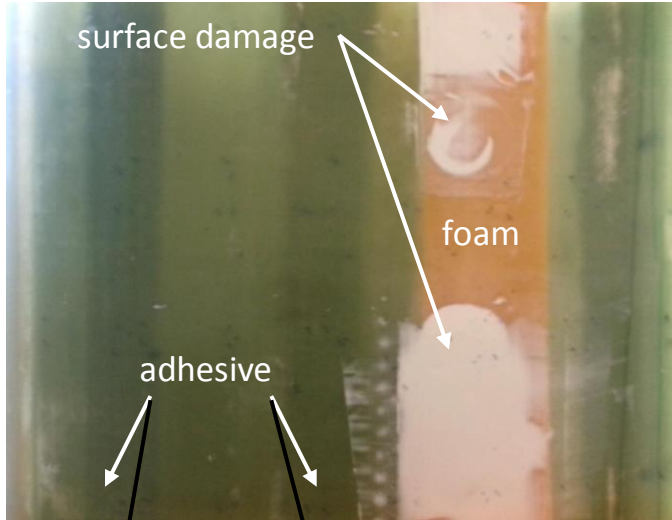
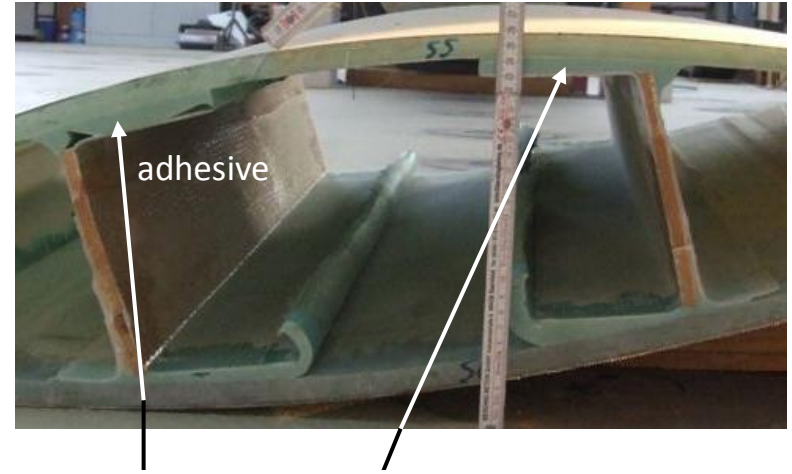
Section of rotor blade with several defects

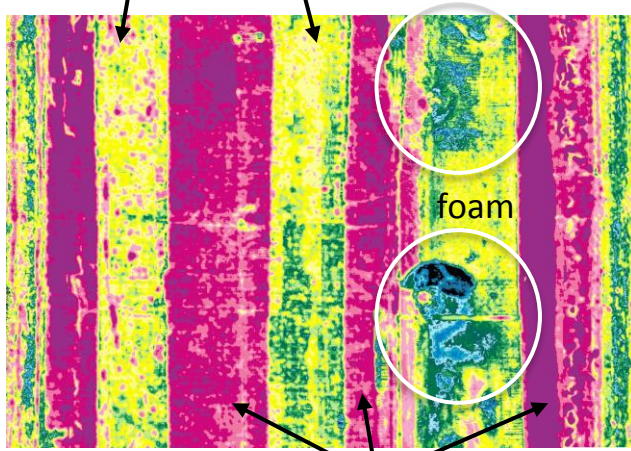
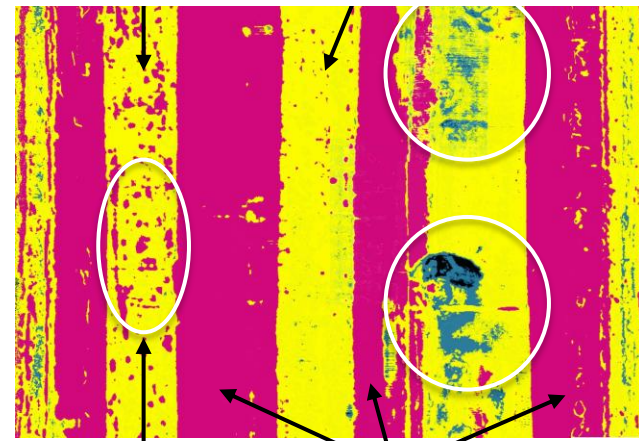
US scan with reduced colours

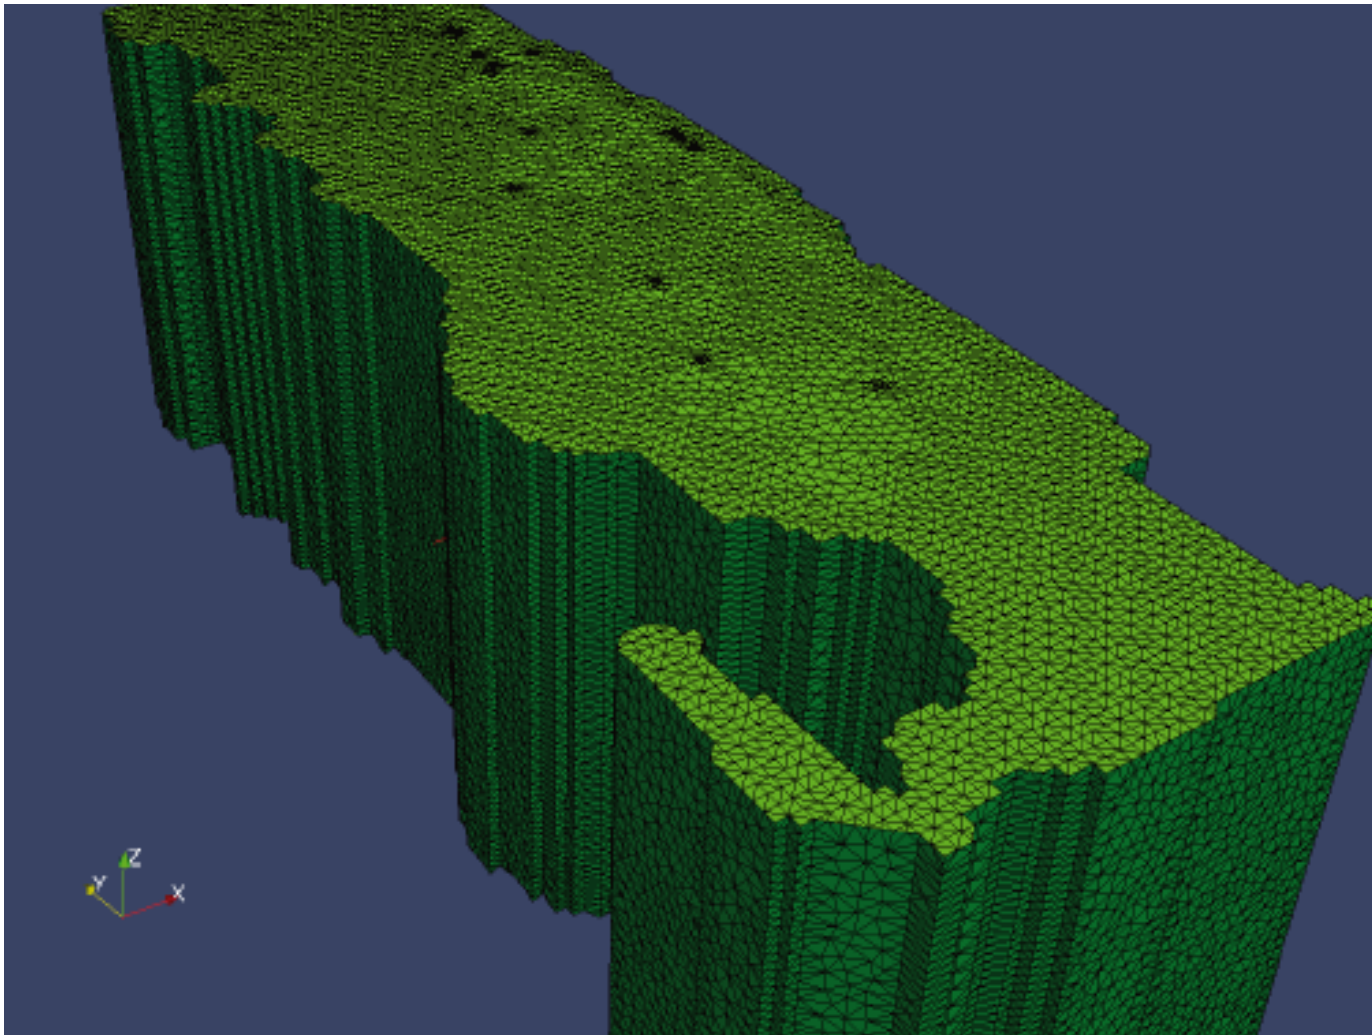
“real” adhesive layer transferred to FE model

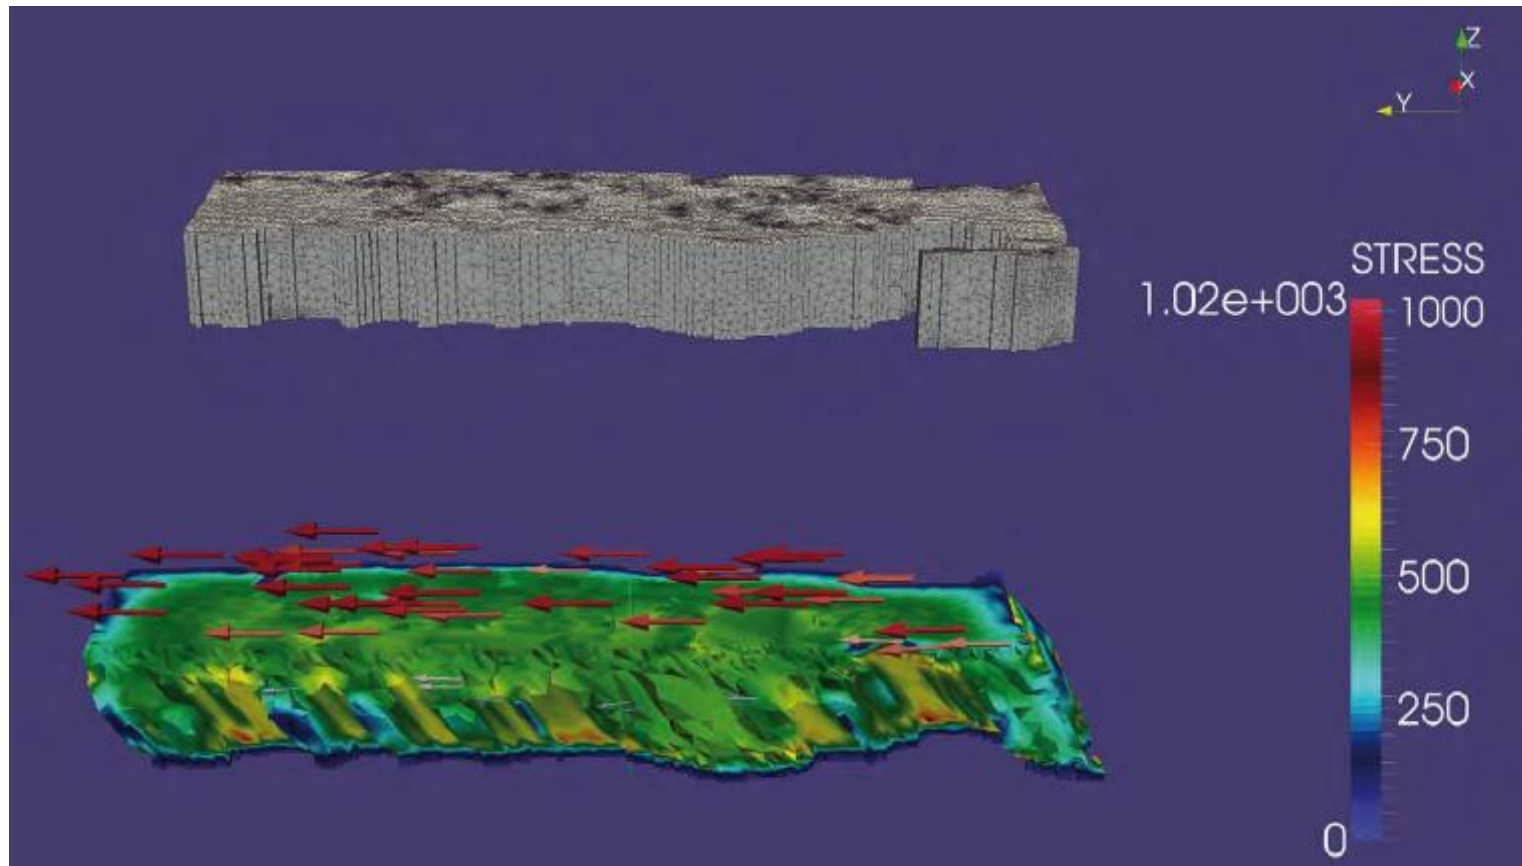
The adhesive layer between two laminate surfaces is filled with volume elements and subjected to shear loading by use of FE simulation

This approach (NDT+FEM) shall provide much more realistic predictions of structural integrity since it is based on real/measured data
